Recommended Solution for Slope Problem within Round Hill Estates North

Committee Report (*draft*) – Nov 8, 2002

Updated with 12/02 erosion pictures and plant types – Jan 29, 2003

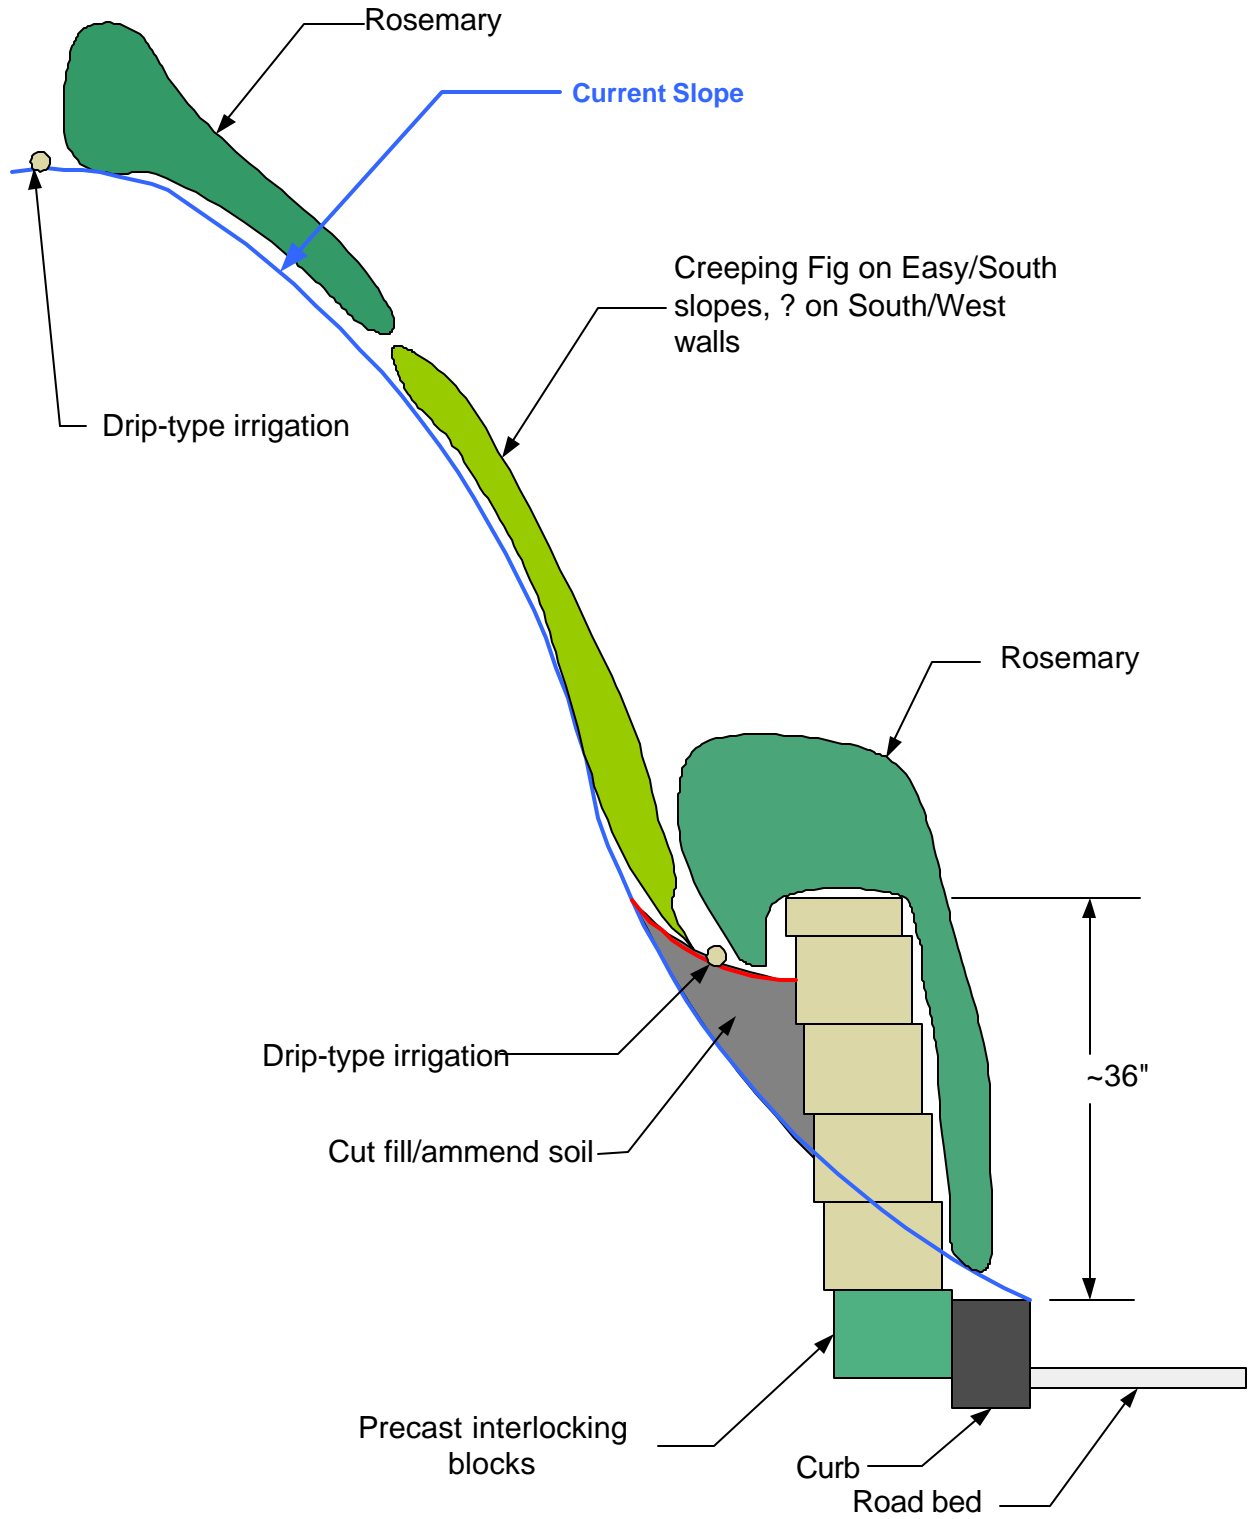
Figure 1 – Profile of slope solution.

Figure 1 illustrates a profile of our proposed solution. A retaining wall needs to be constructed along most of the slope areas identified to a maximum height of about 3 feet above the curb. Some slope areas may not need the retaining wall to be this high and should be evaluated as a function of the slope material and distance from the road. A variety of plant materials are suggested (See Appendix A.) for the different conditions associated with north, south, east, and west facing solar environments. The plantings should be mixed within an area to add interest and to ensure the hardy survive.

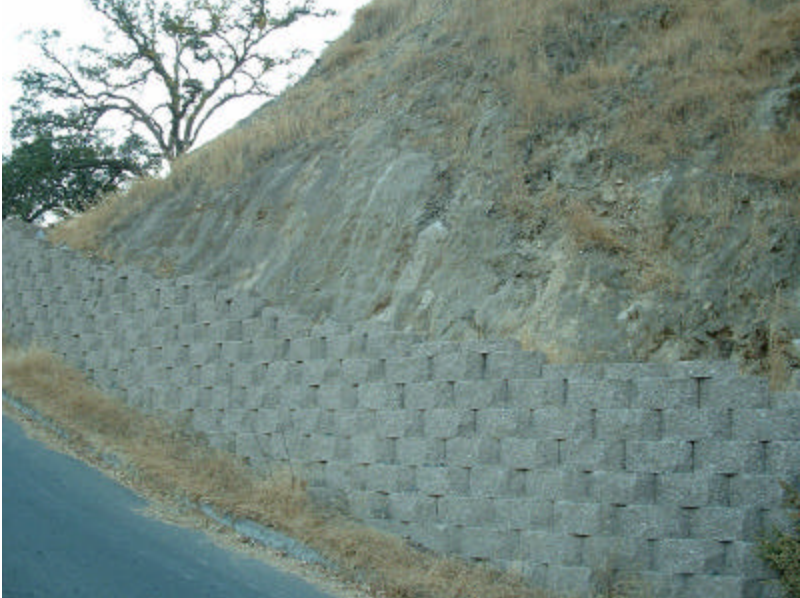
Figure 2. Interlocking retaining wall blocks without plantings.

The retaining wall material can, at a minimum, consist of the interlocking blocks now used for minimal retaining structures of low height. Assuming they are covered with well maintained Rosemary, their appearance would be acceptable. However, using the retaining blocks without any planting would create an appearance like figure 2, which is not a complete solution and quite ugly.

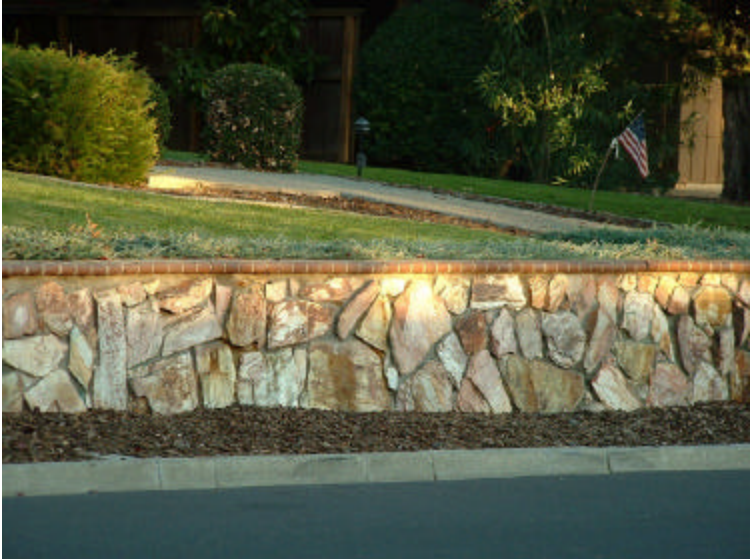
Figure 3. A “first-class” retaining wall.

In concurrence with trying to maintain a “first-class” appearance in our association, a premium wall material would be warranted as it is felt that even well-maintained Rosemary will allow one to see the underlying retaining wall. Figure 3 shows an example of a short retaining wall used in Round Hill Country Club. Examples of “first-class” retaining walls are everywhere with hundreds of flagstone or stone facing materials and brick/stone capping materials available.

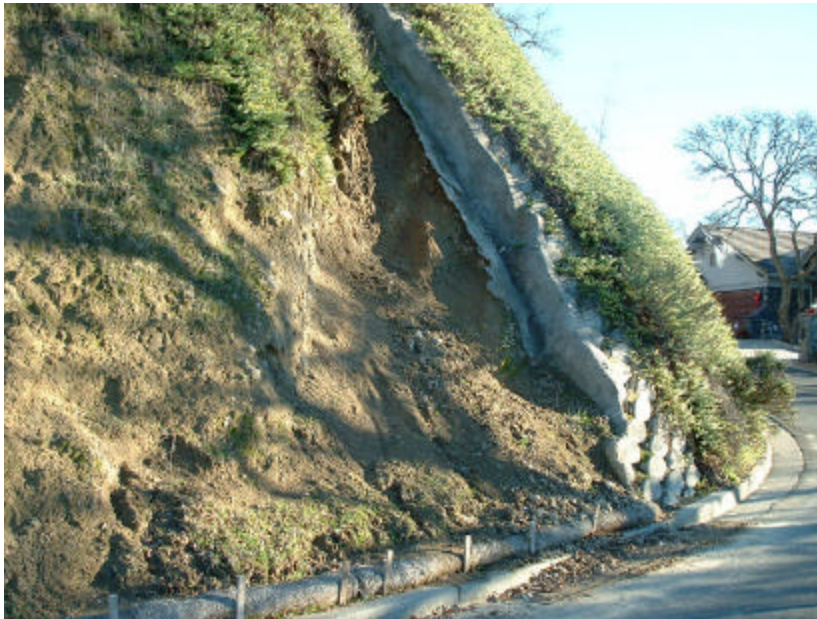
Figure 5. Recent slide is starting to erode under foundation for concrete used to cover drainage pipe.

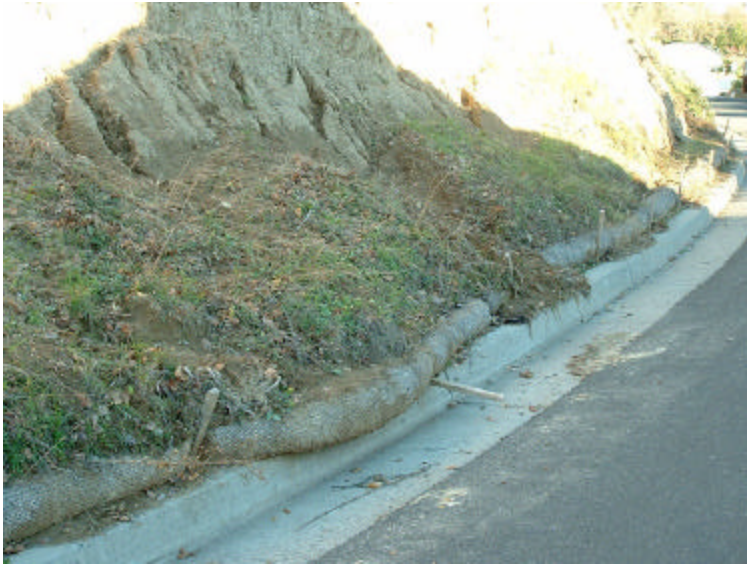
Figure 6. Slide overwhelming temporary straw pipe retaining structure. Erosion has left exposed rock with no soil remaining allowing erosion to start working on these materials.

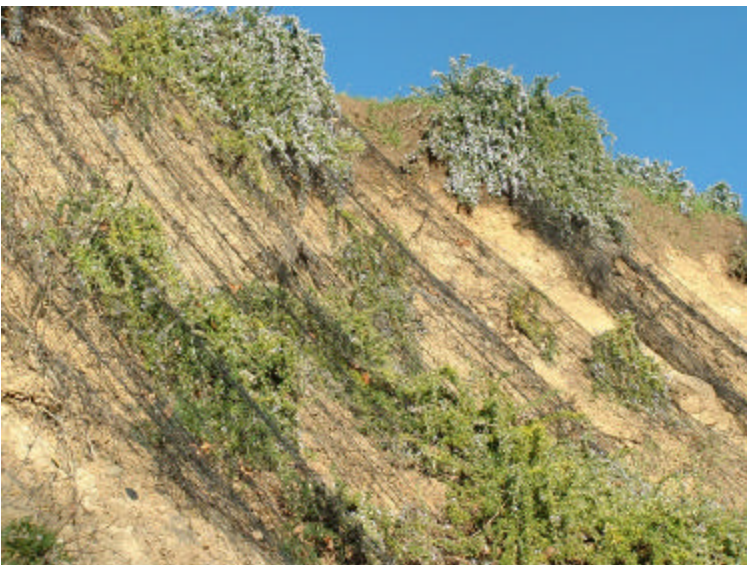
Figure 7. Attempts at erosion control with netting stretched down slope and rosemary planted. Erosion has removed soil under netting leaving it well above ground level and ineffective. Only a small percentage of the originally planted rosemary has survived.

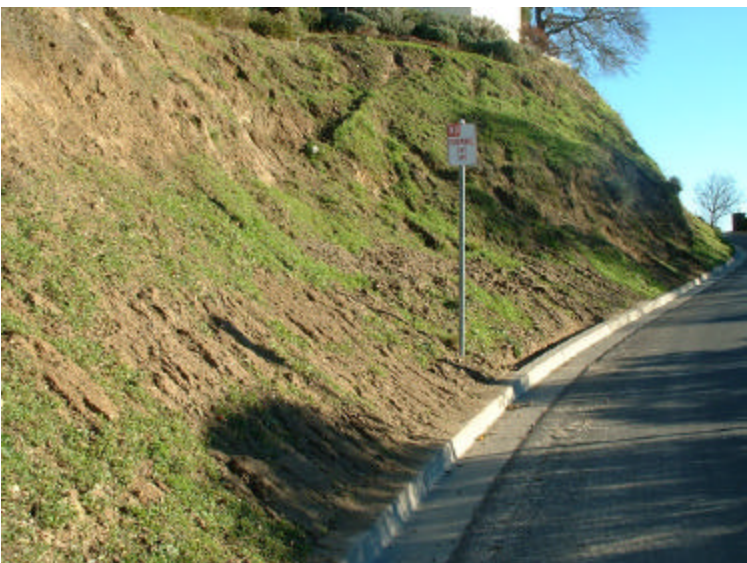
Figure 8. Eroded soil from above is spilling over curb and onto roadway. Almost no vegetation roots are remaining to keep soil from further erosion.

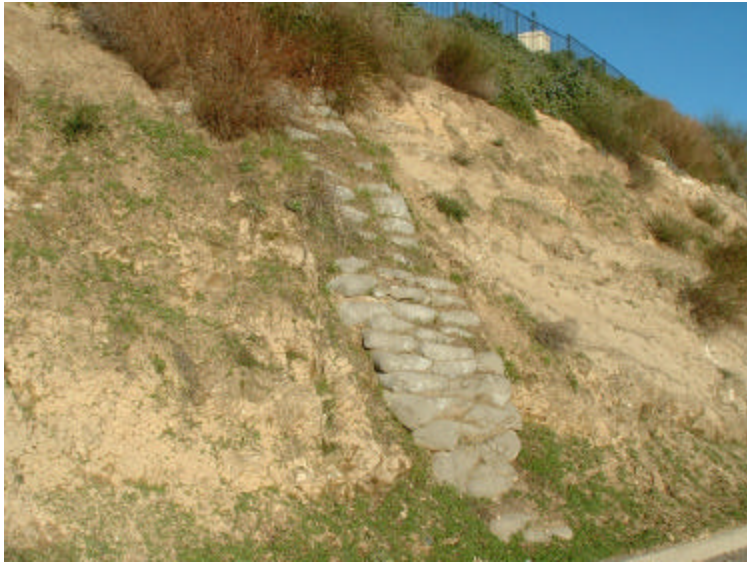
Figure 9. Unattractive cement filled bags covering drainage pipe.

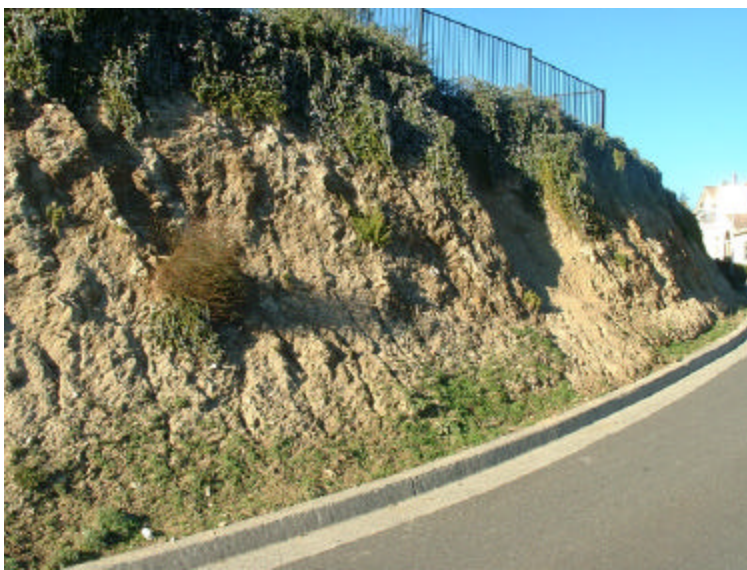
Figure 10. Exposed bedrock has been eroded and channeling is appearing due to runoff from above.

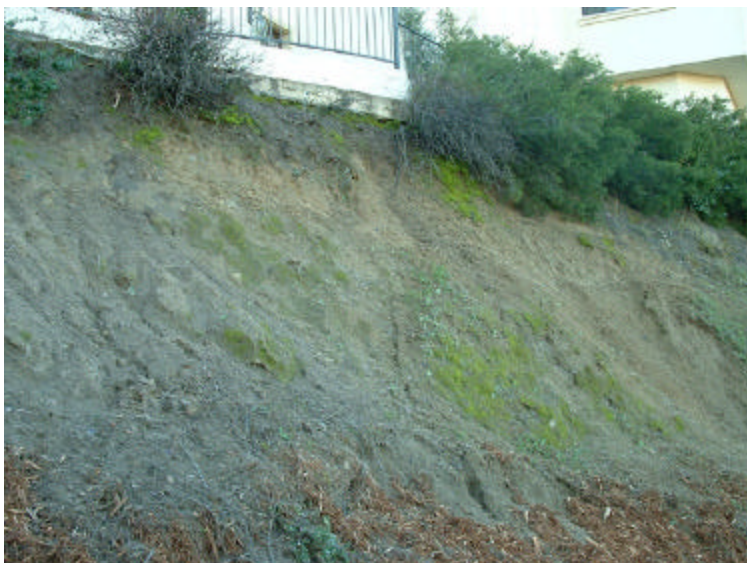
Figure 11. No erosion preventing vegetation roots have allowed ongoing damage to slope and starting to threaten foundation of structure above.

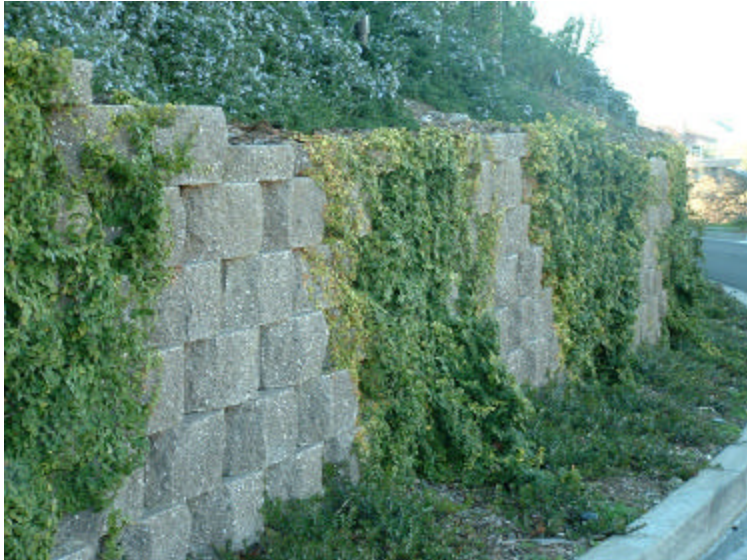
Figure 12. Successful mitigation of slope areas when pool installed on lot 29. Plantings of creeping Fig have started to cover retaining wall with rosemary and morning glory above is making an attractive looking hillside.

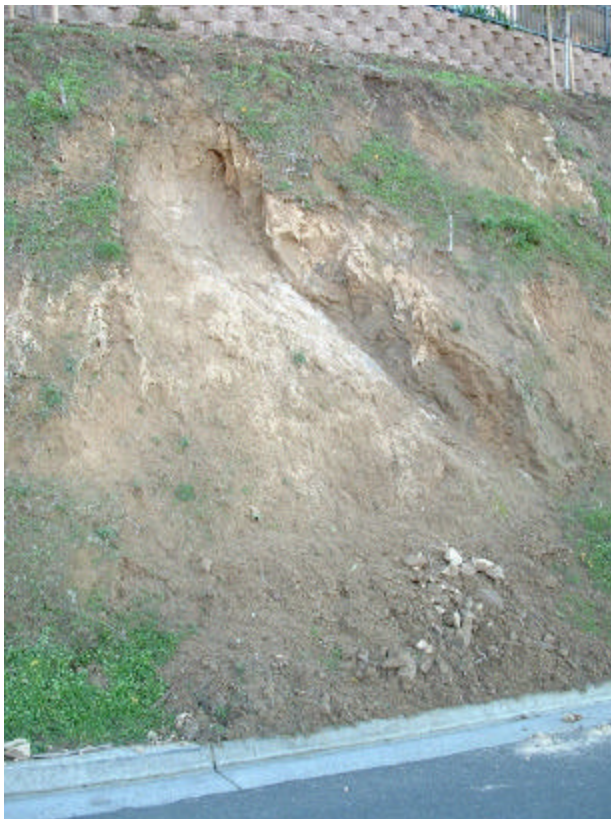
Figure 12. Recent slide taking bedrock out.

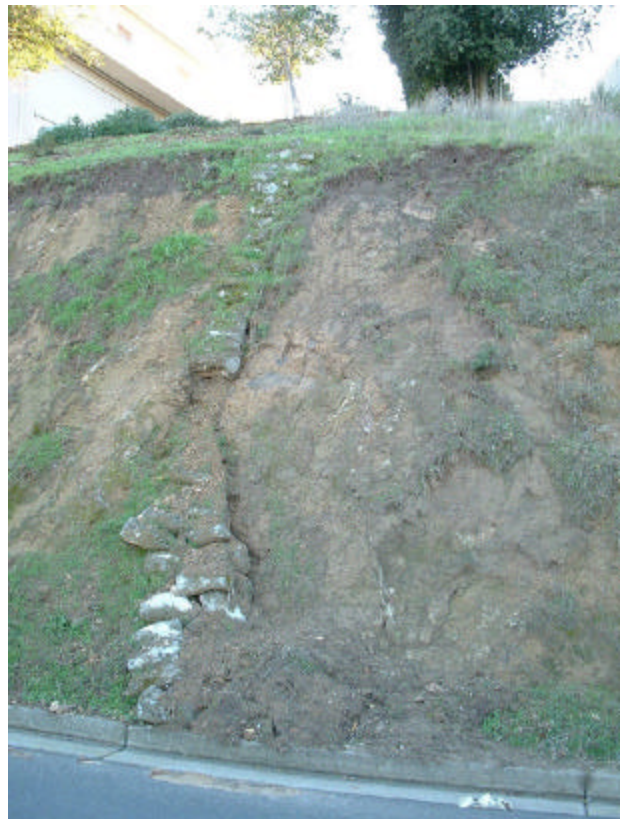
Figure 13. Nearby slide destroying pipe-covering cement filled bags.

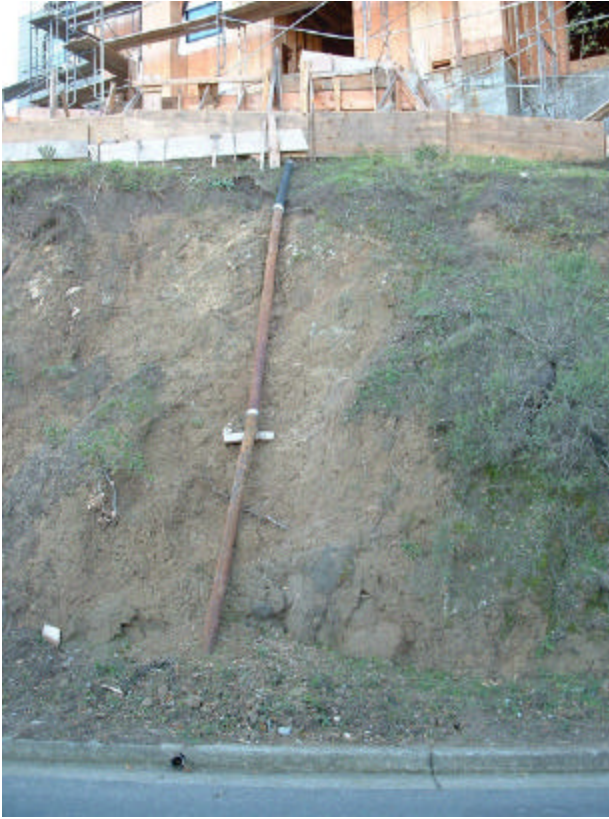
Figure 13. One of the more attractive drainage pipes the residents must view on a daily basis.
